2-Stroke Engine Parts Reconditioning

Al Technology Breakthrough: Breakthrough: KIMI Upgrades Market's Standards

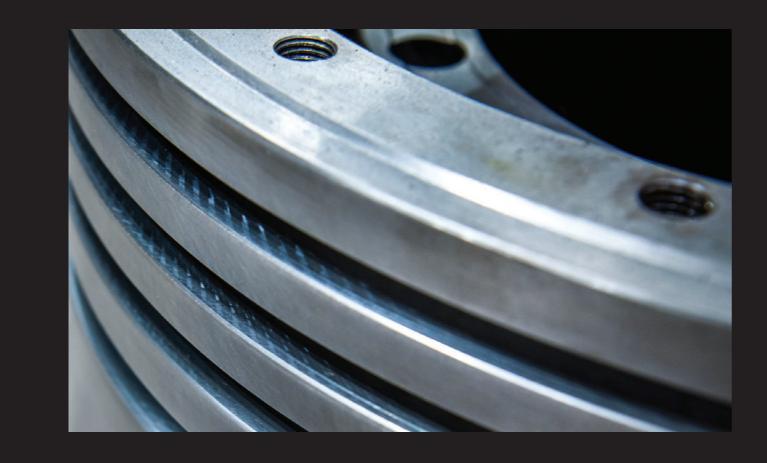
Piston Crown

We do not just recondition, we fully rebuild piston crown.

We offer an end-to-end seamless rebuilding procedure for piston crowns that involves 3D-scanning evaluation, AI powered welding robotics and latest technology CNC machines. Piston ring grooves are completely removed and re-built from scratch.

KIMI's cutting edge In-house chrome plating infrastructure guarantees both full compliance with Maker's specifications and increased durability. Grooves are grinded on each side and maximum grinding parallelism deviation is 0.01mm while the net chrome plating thickness is 0.50 mm on each piston groove side.

Our rebuilding service for piston crowns ensures full restoration of the pistons' service life. Full warranty of 20.000 running hours is offered for piston crowns rebuilding service.

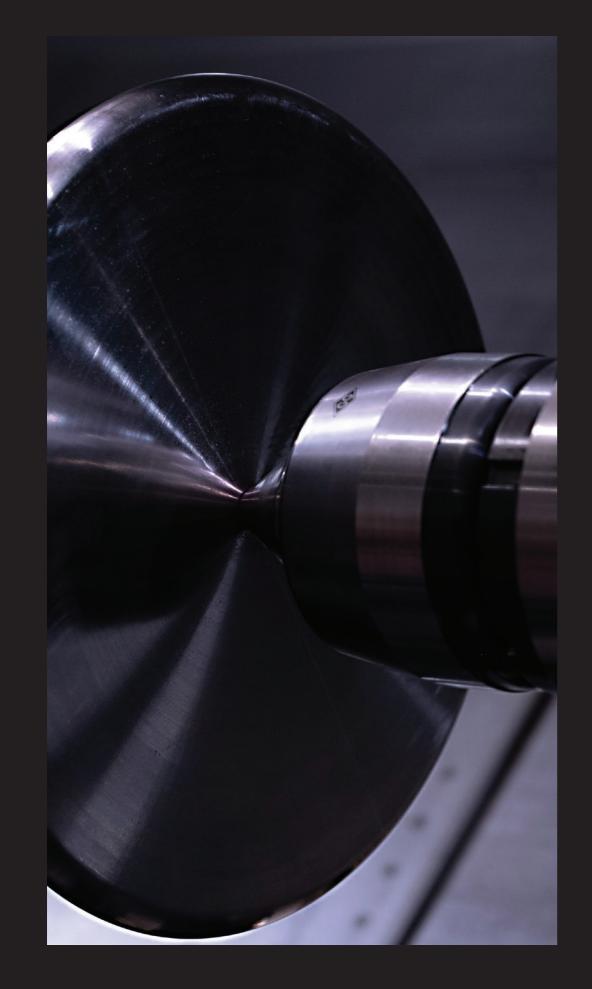
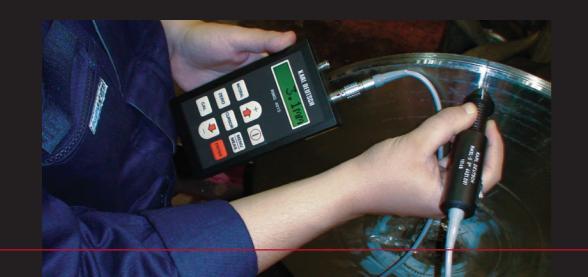
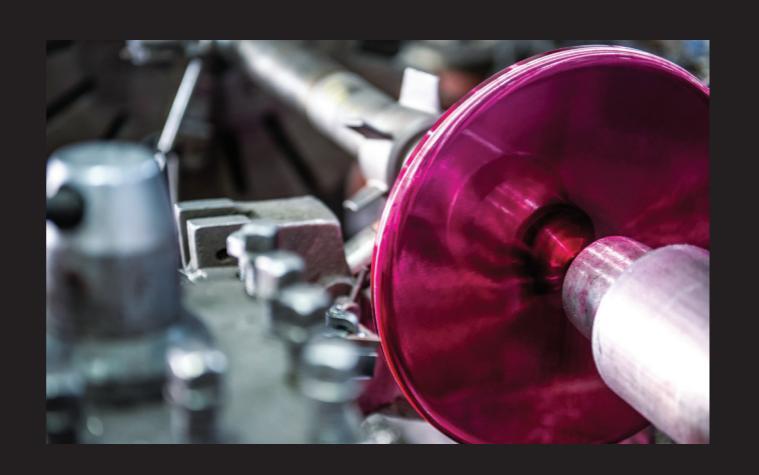
Exhaust Valve Spindle & Seat

Our streamlined reconditioning procedure for exhaust valve spindles includes careful identification of the material composition and metallurgical examination, geometry evaluation through 3d scanning, CNC machining, AI welding robots, and quality checks by Level II PCN certified personnel prior to, during and after every production phase.

KIMI offers a highly adaptable reconditioning service for valves of all material types and specifications -Duraspindle, Nimonic, Stellite. Our rebuilding service for exhaust valve spindles ensures that reconditioned spare, both metallurgically and dimensionally, is equivalent to a new valve. The exhaust valve seat is fully rebuilt following the same procedure.

Failing to identify the exact material composition or applying inadequate welding procedure can lead to valve spindle failure during engine operation.

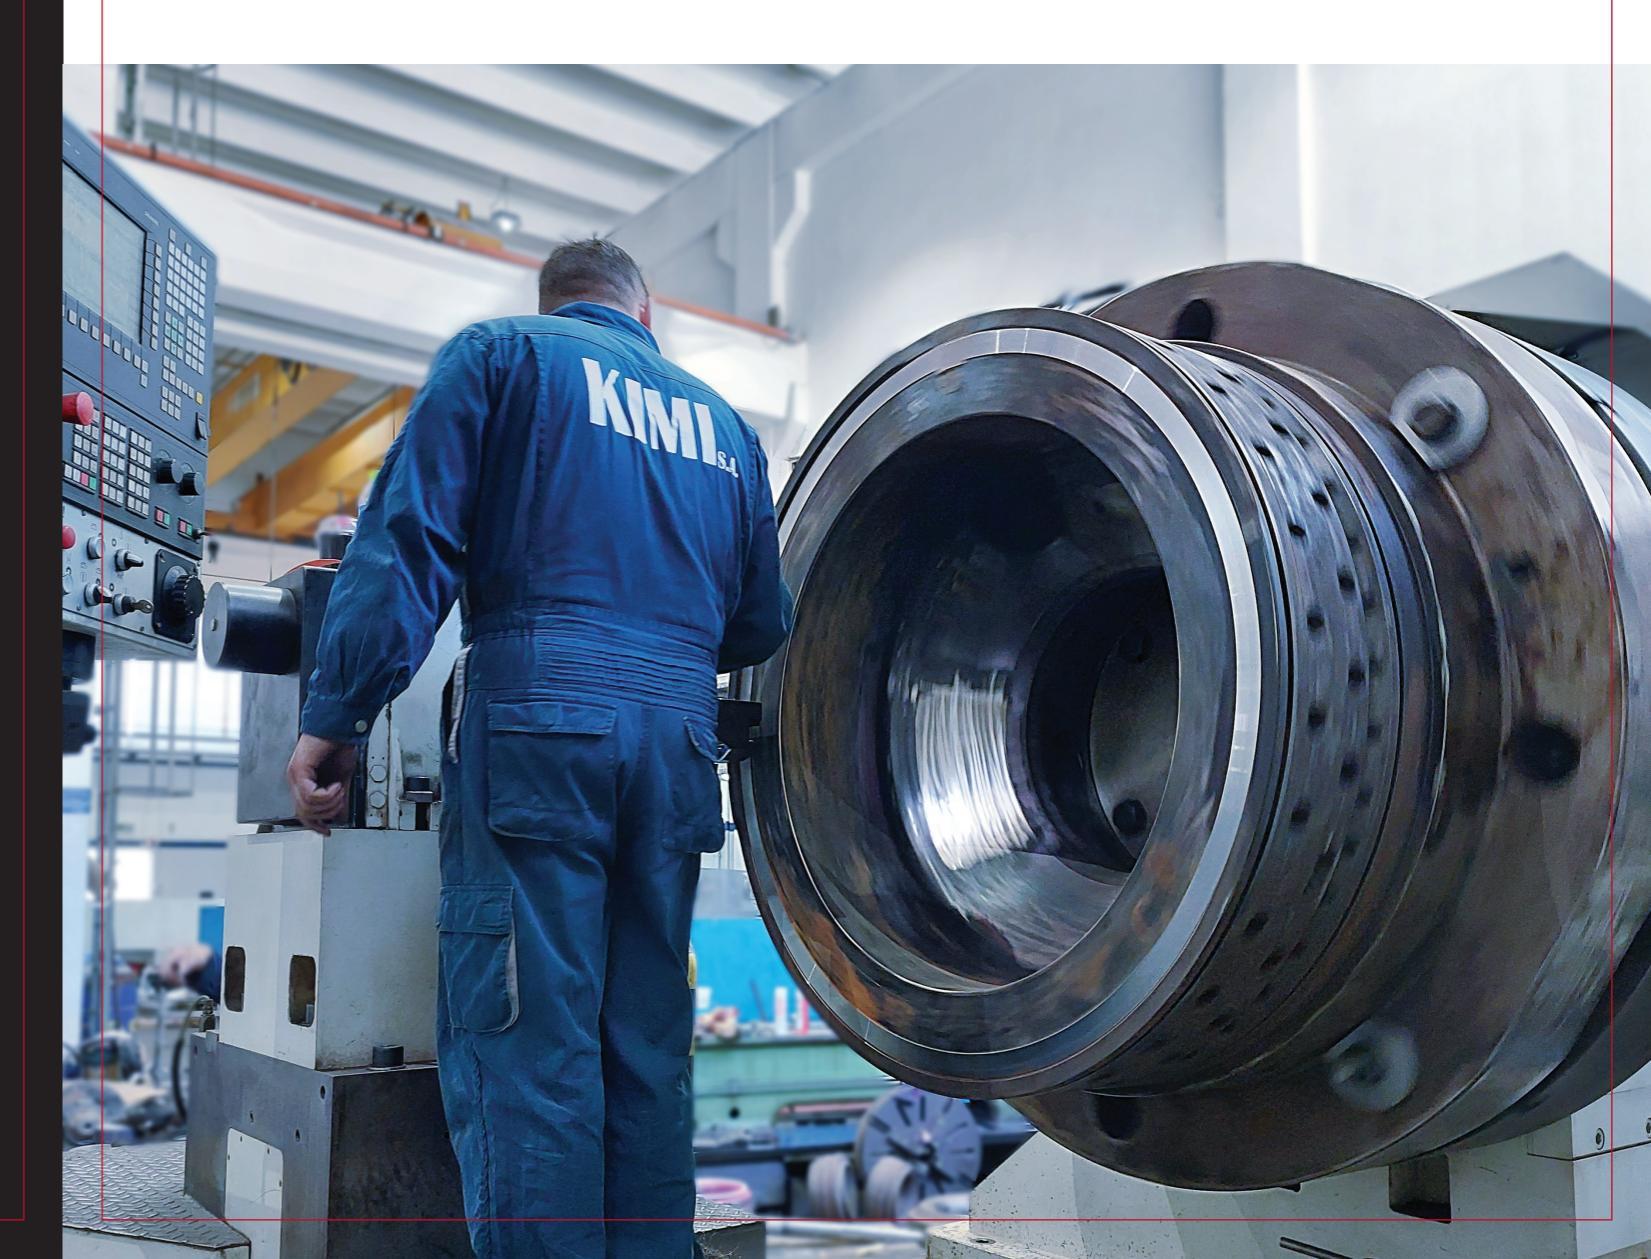
Cylinder Cover

KIMI reconditioning service is designed to restore 2-Stroke cylinder covers of B&W, Sulzer, Mitsubishi engines back to their original dimensions and tolerances. During the inspection of the cylinder cover, proper application of non-destructive testing (NDT) is critical to detect cracks and defects.

When it comes to heavily damaged cylinder covers, KIMI offers a full rebuilding service of the combustion surface, not only a partial reconditioning. Welding and stress relieving is carried out under precise controlled conditions. Combustion's face, landing faces and O-ring grooves are machined on vertical CNC turning table to the original dimensions as specified by the Maker. Finally, the covers are pressure tested, dye checked and visually inspected by certified personnel.

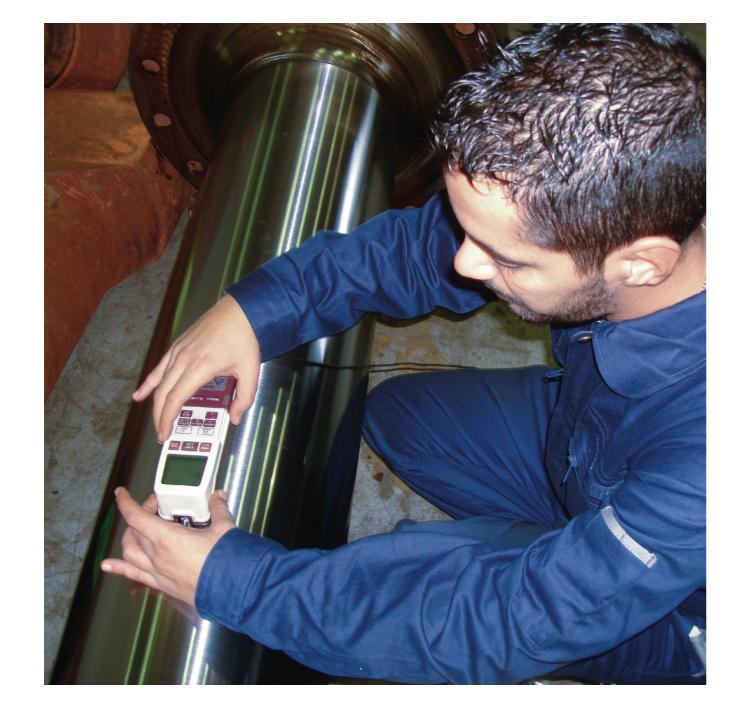
For piston rods, two critical factors determine resistance to wear after reconditioning: surface hardness and roughness. In addition to the commonly used submerged arc welding method, KIMI applies the laser cladding technique as a premium repair option that obtains high surface hardness and ensures a long lifespan of the reconditioned piston rod.

In every case initially, piston rod is subjected to inspection- dimensional measurement, chemical analysis, hardness test and NDT by PCN II certified personnel.
